# Technical Report — Abnormal Tracker Operation Following the Side-Rivet Bearing Retrofit, Arctech SkyLine II

Plants: Angol · Falcon · Dinamo · Los Sauces I (PowerTree / Hergo / Infrastrutture portfolio)  
Prepared by: iEnergia Group — Project Management & QA · Contractor entity: Visibility S.A.  
Ref. IEN-ARC-BRG-001 · Rev. 05 · 21 August 2026 · Scope: tracker bearing system and tracker operation only

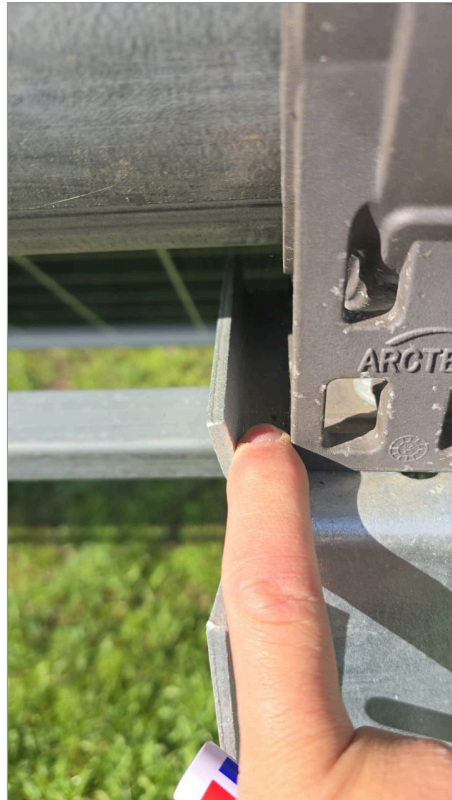
The photographs below were taken on 11 and 17 August 2026. The black plastic bearing has moved along the torque tube and is now **bearing hard against the face of the bearing housing**. Rubbing marks and powdery residue can be seen at the contact, and material has been lost there — the parts are being forced to move against each other at a surface that, in the original design, they did not load in this way.

**Figure 1 — 11 August 2026.** The black plastic bearing, displaced along the torque tube, pushed against the face of the Arctech bearing housing. The finger indicates the contact.

The side rivets changed that: the bearing is now fixed to the torque tube. What we observe in the field is that the fixed bearings have been driven along the tube until they bear against the housing, and that the trackers then bind and release in steps. One mechanism we have considered, and which appears consistent with the pattern — its emergence over months, and its worsening through the colder season — is the natural change in length of the steel tube with temperature, which the bearing can no longer let pass now that it is fixed to the tube. But we present this only as a working hypothesis. Whether the driver is thermal movement, tolerance take-up, wear, a combination of these, or something else, **is precisely what Arctech's root-cause investigation needs to establish** — with the actual row geometry, drive positions and bearing condition examined jointly on site.

| # | Request |
|---|---|
| 3 | A root-cause investigation by Arctech engineering into the displacement of the plastic bearing against the housing and the binding/knocking during movement, taking into account the as-built row geometry and the bearing freedoms defined in Arctech's own installation manual, and including the condition of the rivet connections to the tube. |

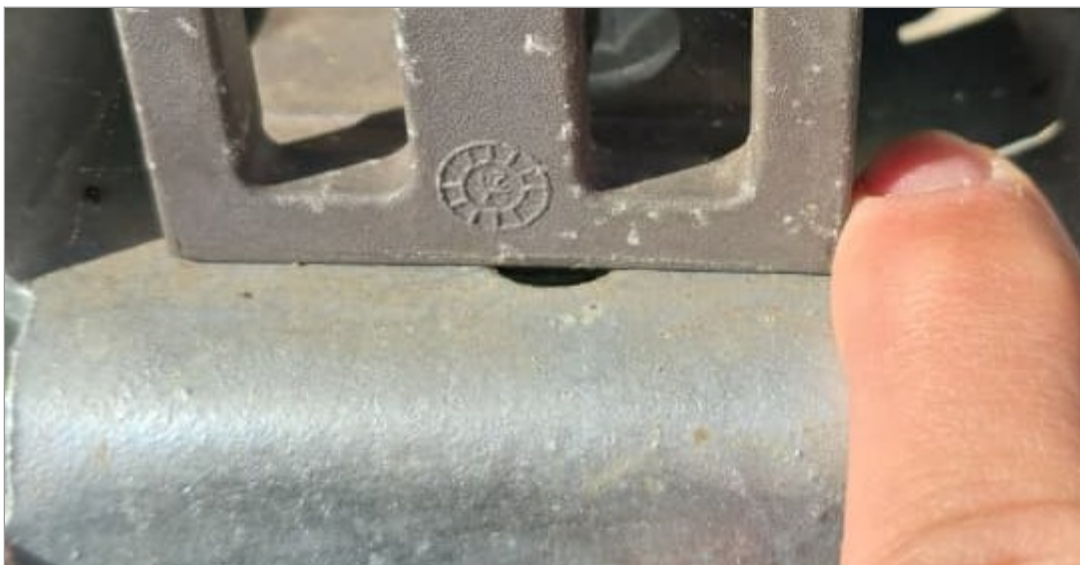
**Figure 2 — the same contact, closer.** Rubbing marks and residue where the plastic bearing meets the housing, and the small void where material has been lost.

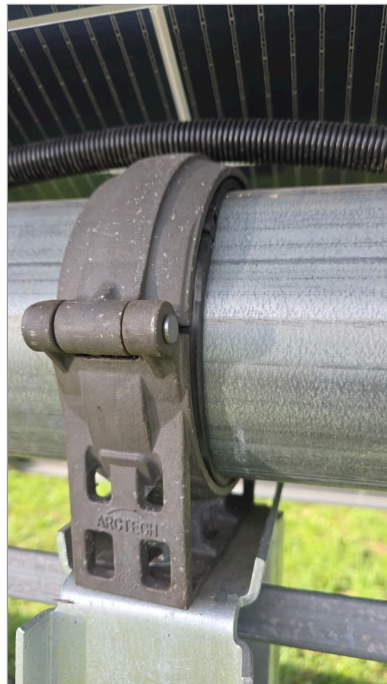
**Figure 3 — the assembly, general view.** The hinged Arctech bearing housing clamped over the black plastic bearing on the galvanised torque tube.

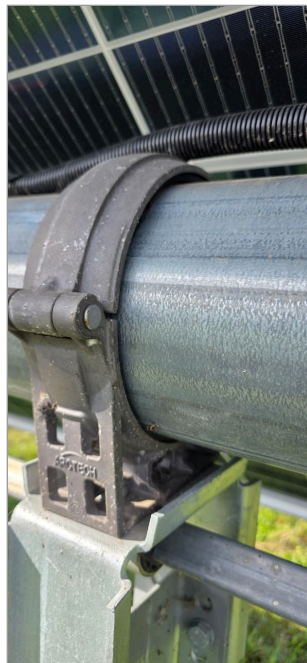
**Figure 4 — 17 August 2026.** A second position, inspected six days later: same condition.

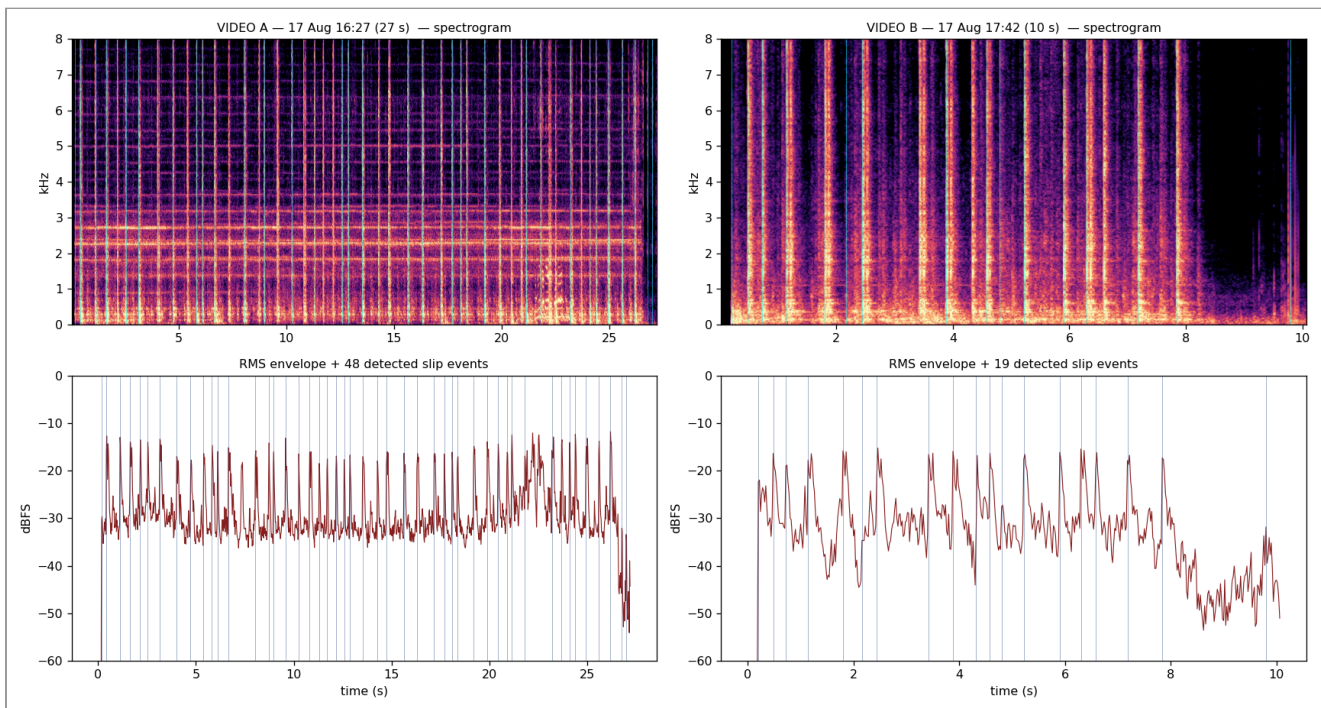
- a loud, sharp impact roughly **every half second** while the tracker moves — 48 impacts in the first recording (27 s), 19 in the second (10 s), at an almost constant rhythm in both;
- each impact followed by a brief metallic ringing of the structure; and
- in the second recording, the noise **stops completely the moment the tracker stops moving**.

Wind or background noise does not keep a steady rhythm, and does not switch off with the tracker. The recordings and the full analysis are annexed.

**Figure 5 — sound analysis of the two recordings.** Each vertical line is one impact. Left: 27-second recording, 48 impacts. Right: 10-second recording, 19 impacts; all activity ceases at ~8 s when the tracker stops.
